**PRELIMINARY ASSESSMENT/
VISUAL SITE INSPECTION**

**1330 SOUTH KILBOURN AVENUE FACILITY
FORMERLY THE VALSPAR CORPORATION - PAINT
CHICAGO, ILLINOIS**

FINAL REPORT

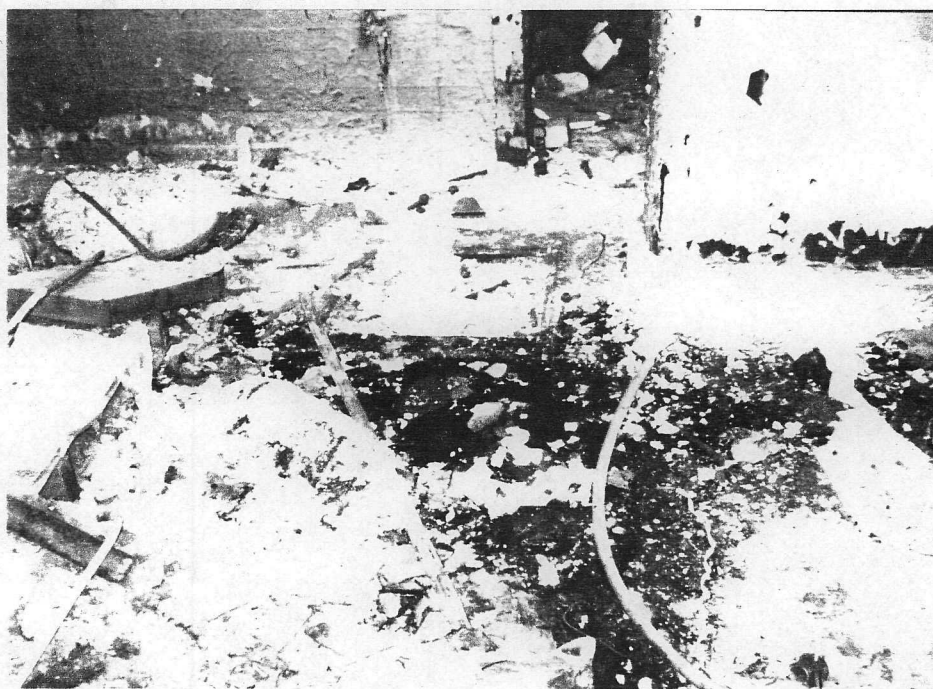
Photograph No. 56

The complex of Buildings 9, 9-A, 9-B, and 9-C appear to have been used as the source of power for the facility when it was operational (see photographs 55, 56, 57, and 58) (Armstrong Paint, date unknown). Building 9-A and 9-C are two-story buildings, and the other two buildings are one-story structures. The first floors of these buildings all contain electrical equipment in various stages of disrepair. PRC observed at least two boilers, one engine, and several control panels that had been partially torn from the wall. The engine was resting in a brown liquid with oily sheens on its surface. PRC observed pools of black, oily materials near the west end and in the center of Building 9-C and oily stains on the walls and floors in all the buildings. PRC observed one empty drum in Building 9-A. The floor of every building was covered with debris and rubble piled to 1 foot high in places. The rubble consisted of concrete, metal, and wood scraps, white powders, dust, and chipped paint from the walls and ceiling. PRC also observed deteriorated piping insulation in these buildings. PRC observed two sealed, 55-gallon drums in Building 9. The ceilings in Buildings 9 and 9-C were quite high, approximately 30 to 50 feet above the floor level in places. Information obtained by PRC after the VSI indicate that three underground storage tanks containing fuel oil for the boilers and engines are located in Building 9-C. Two of these tanks have a capacity of 25,000 gallons; the third has a capacity of 10,000 gallons (IT, 1990b). PRC did not locate the accessways or fill pipes to these tanks during the VSI. PRC determined that these four buildings have a combined floor space of about 5,400 square feet on the first floor (see Table 1).

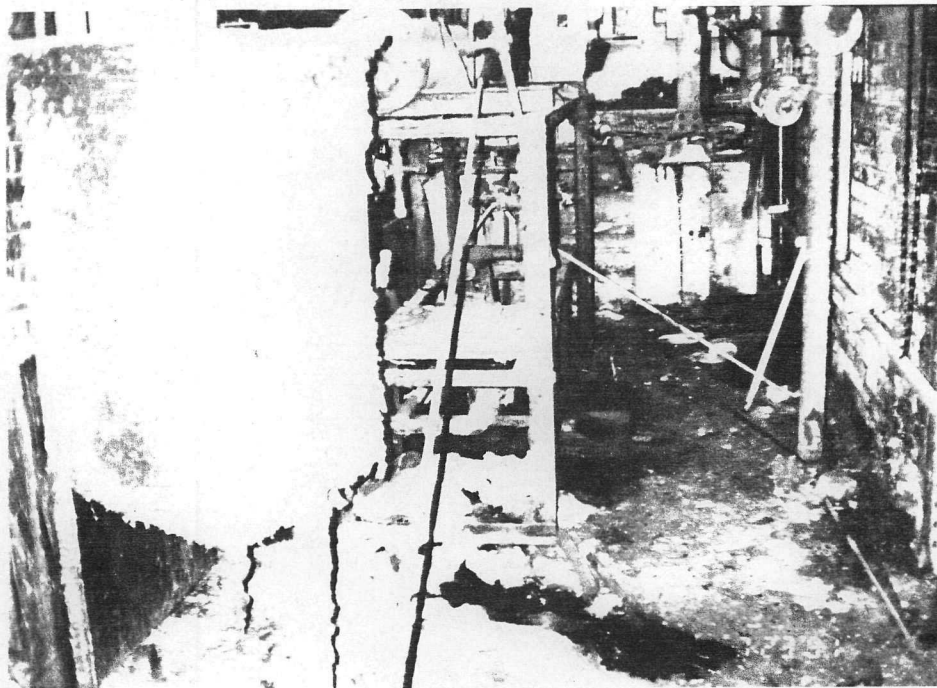
Photograph No. 57

Description: This picture shows part of the boiler room in Building 9-C. Note the oil pools on the floor. The oil may contain PCBs. Piping insulation that may contain asbestos is also visible in this picture.

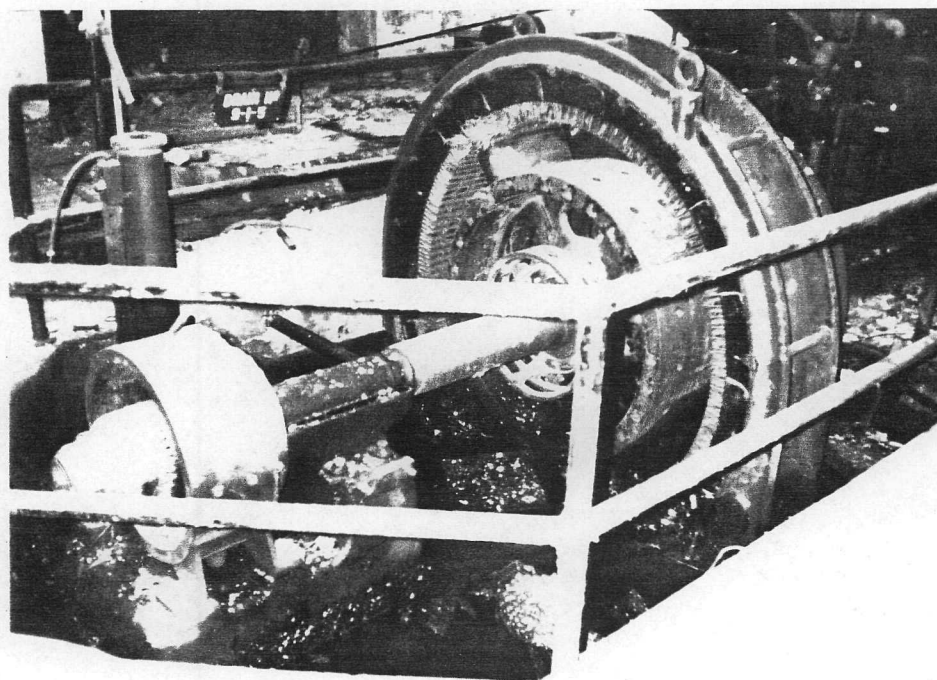
Photograph No. 58

Description: This picture shows the power drive on a boiler engine in Building 9. The power drive is located in a trench that was partially filled with a dark liquid, possibly oil. If the liquid is oil, it may contain PCBs.

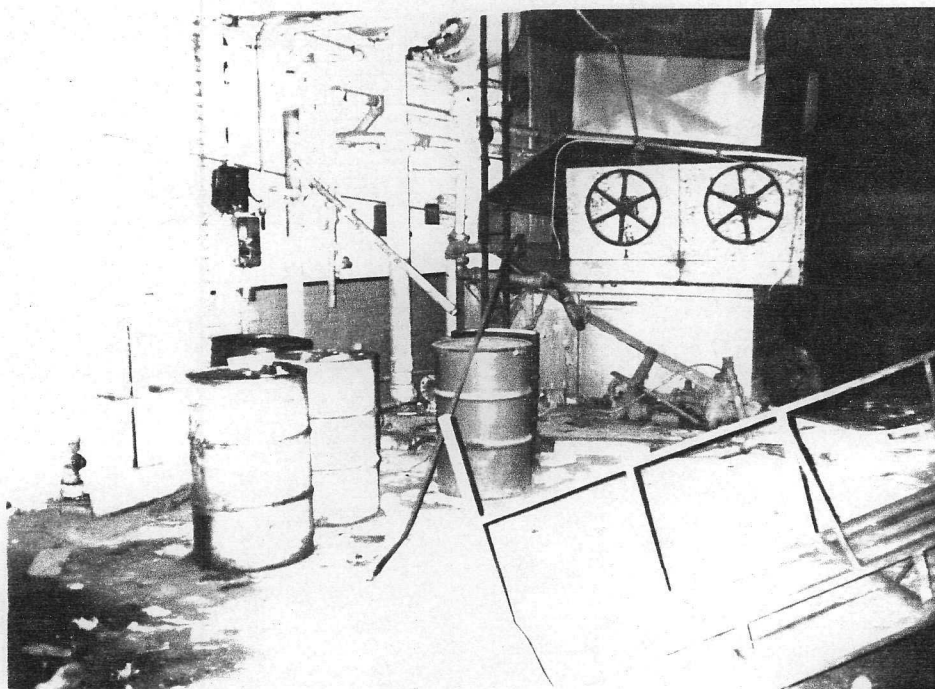
Photograph No. 59

A wall divides the first floor of Building 8 into two areas (see photographs 59, 60, 61, 62, 63, 64, and 65). PRC observed seven 55-gallon drums, white powders, oily stains, and standing liquid in the southern section of the floor. Using a photoionization detector (PID), PRC

Description: This picture shows six drums in Building 8. One of the drums contained volatile organics (headspace readings of 600 ppm were taken). The other drums may contain oil and possibly PCBs. Note the white dust on the floor of this building in the right background. Also note the oily stains in the lower left corner of the picture.

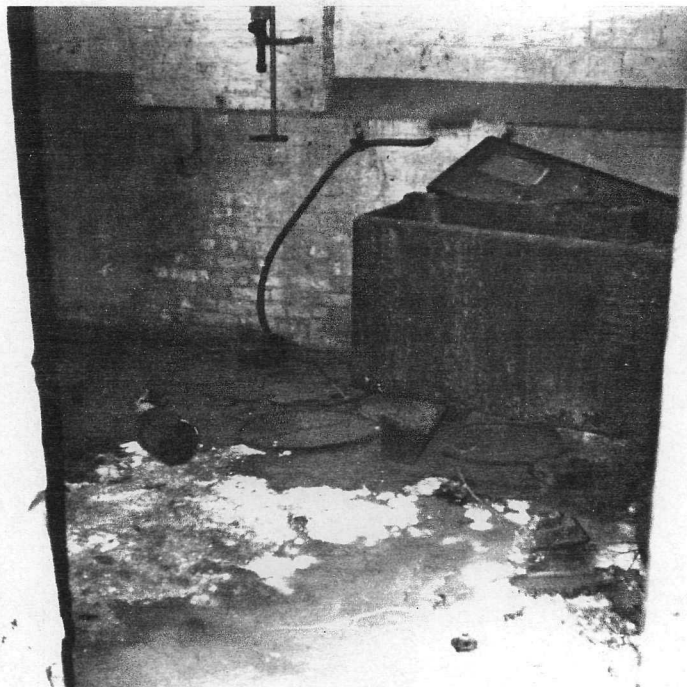
Photograph No. 61

Description: This picture shows the room in the southwest corner of Building 8. The white stains in the center of the picture resembled caustic residue. Note the dust in the lower right corner of the picture.

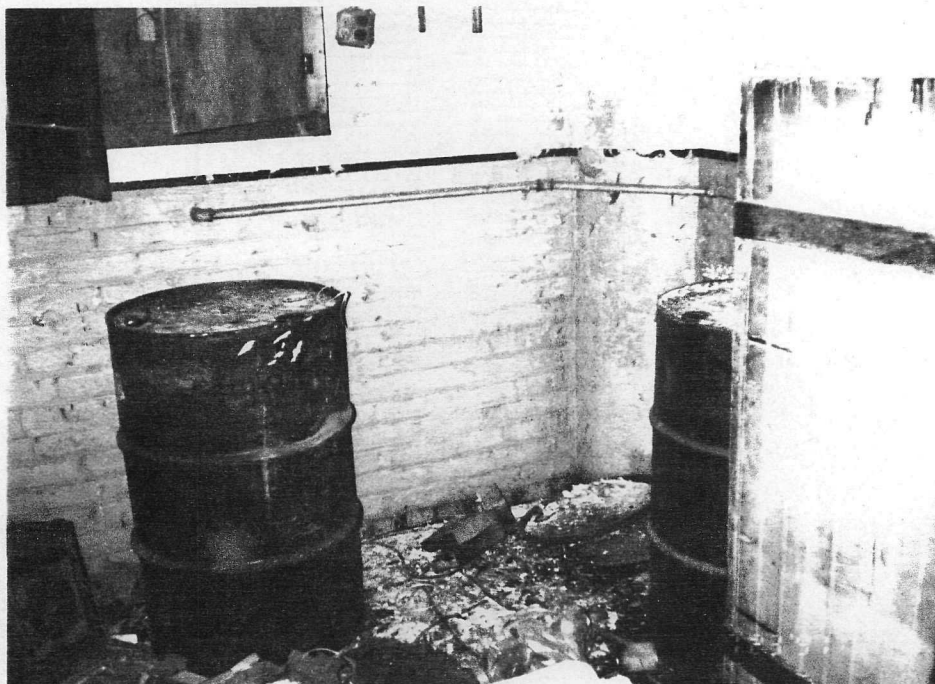
Photograph No. 65

Description: This picture shows two drums located in the southwest corner of the generator room in Building 8. Both drums contain volatile constituents (headspace readings of 0.2 and 50 ppm were taken). Note the white dust and peeling paint in this corner.

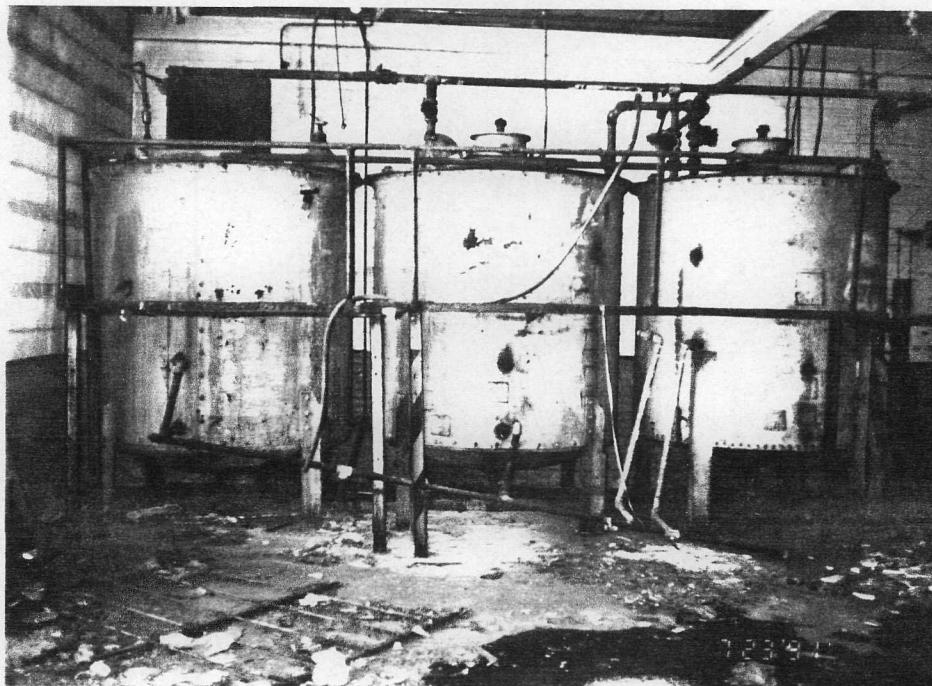
Photograph No. 66

The first floor of Building 10-A contains three cylindrical tanks and one drum (see photographs 66 and 67). The floor was covered with debris, including pools of standing liquid, white dust, and paint chips. Several of the windows on this floor of Building 10-A were boarded up. According to information provided to PRC after the VSI, no tanks were located in this building (IT, 1990b). However, Building 10-A is attached to Building 10, and PRC believes that the three tanks that it observed may be three of the tanks identified as present in Building 10. PRC determined that Building 10-A has a floor space of about 3,600 square feet (see Table 1).

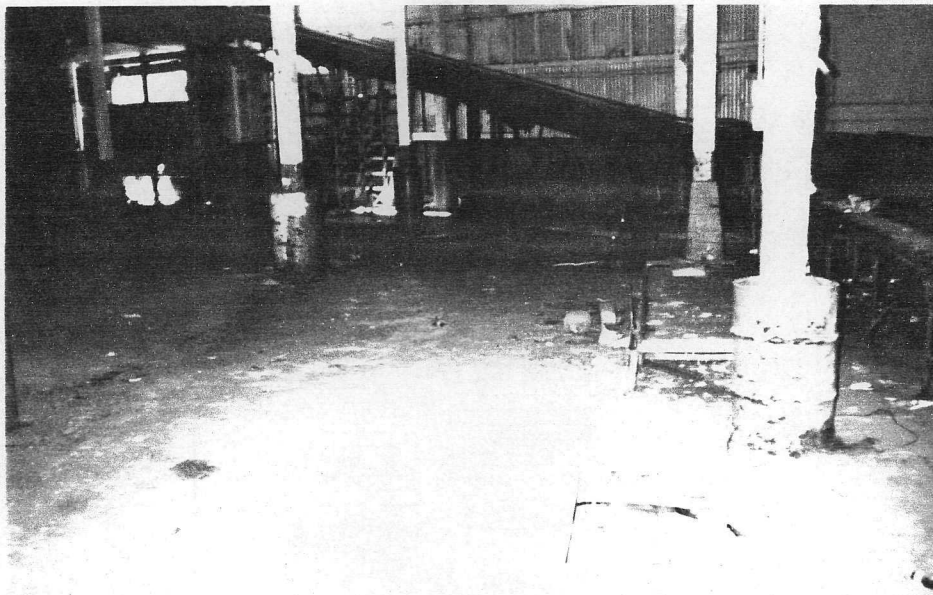
Photograph No. 69

The first floor of Building 11 contains a conveyor belt along the west and north walls (see photographs 69 and 70). The floor of the building was covered with dust and miscellaneous debris. PRC identified at least two holes in the floor. Plywood sheets had been placed over the holes to prevent anyone from falling into them, according to Goodwill. PRC observed one tank on the first floor of Building 11. The tank appeared to be a 20-cubic-yard roll-off box with a fitting placed over a hole in its top to allow for filling and emptying operations. The ceiling of

Description: This picture shows a tank accessway located on the first floor of Building 11. The accessway apparently leads into a tank located in the basement of this building. A number of these accessways were covered with plywood sheets. PRC did not disturb any of these coverings.

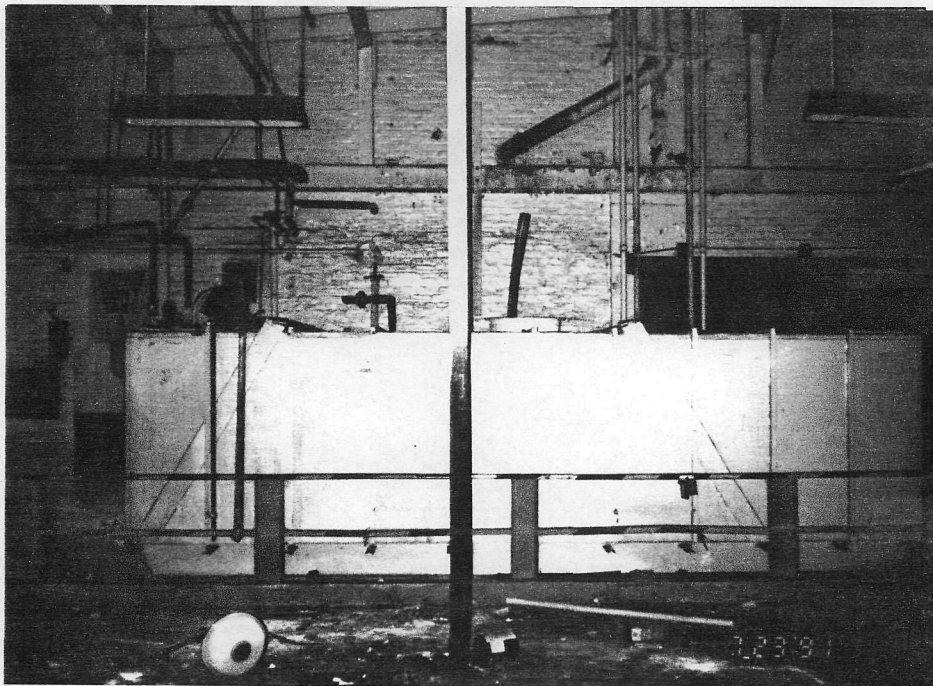
Photograph No. 70

Description: This picture shows a large tank located against the south wall of the first floor of Building 11. An accessway into the tank is located on top of the tank, but PRC did not examine this closely because of safety concerns. The yellow guardrails around the tank may indicate that it contained hazardous constituents or that the tank was in some other way dangerous. Note the white powder on the floor in front of the tank. The tank was labelled "Valspar."

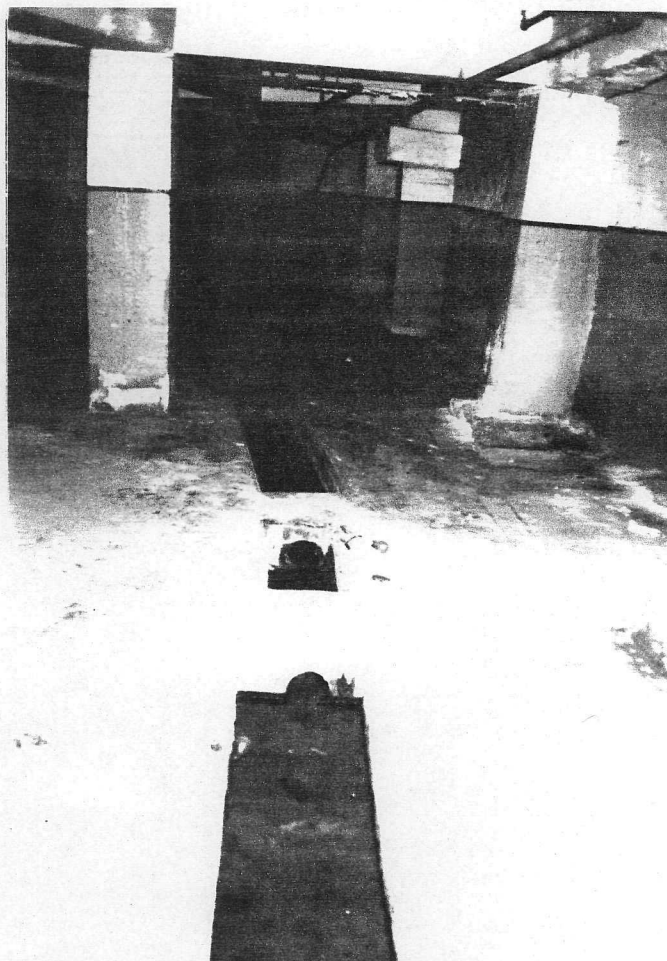
Photograph No. 71
Location: Building 11
Orientation: North
Date: 07/23/91
Description:

This picture shows a trench running in a north-south direction in the basement of Building 11. The trench was filled with a yellow-colored liquid. Note the white powder throughout the room.

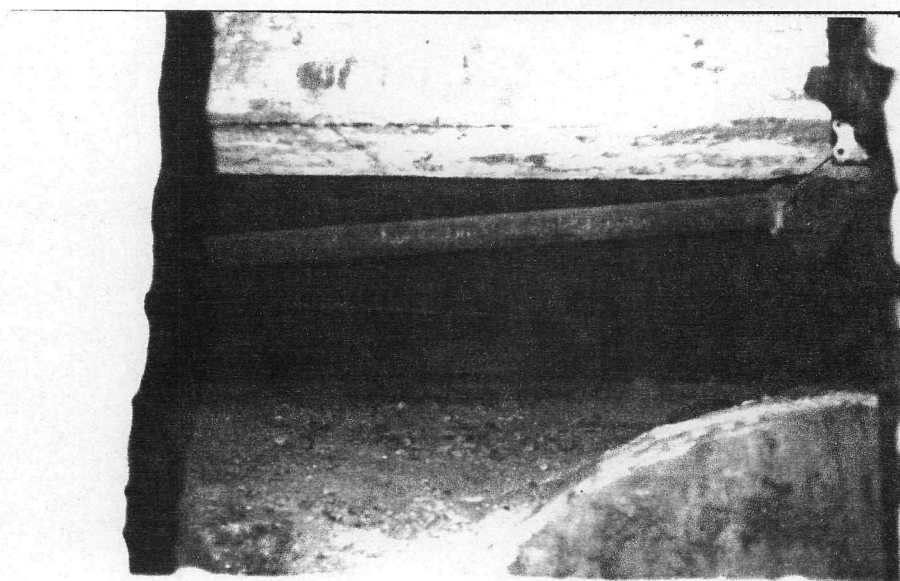
Photograph No. 72
Orientation: North

Description: This picture shows a number of tanks partially buried with dirt or fill. This picture was taken through a rectangular opening in the wall of Building 10 and may show the area underneath Tanks 1, 2, 3, and 4. However, the exact location of these tanks with respect to the tanks on the first floor is unknown. No basement plans were provided by Goodwill or Valspar representatives.

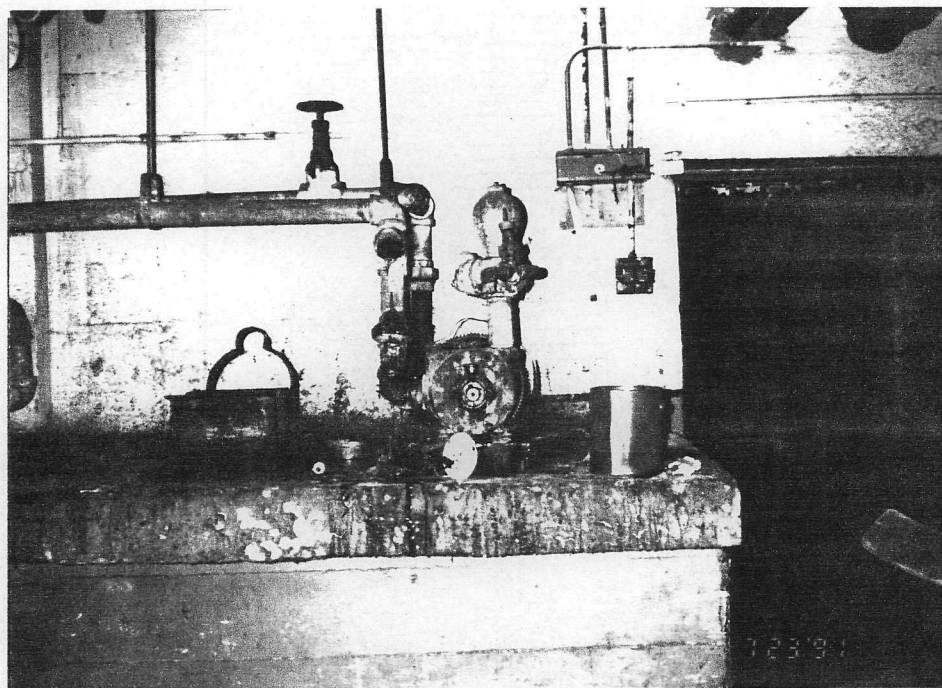
Photograph No. 73

Description: This picture was taken in the basement of Building 11. It shows a leaking pipeline that probably contains resin.

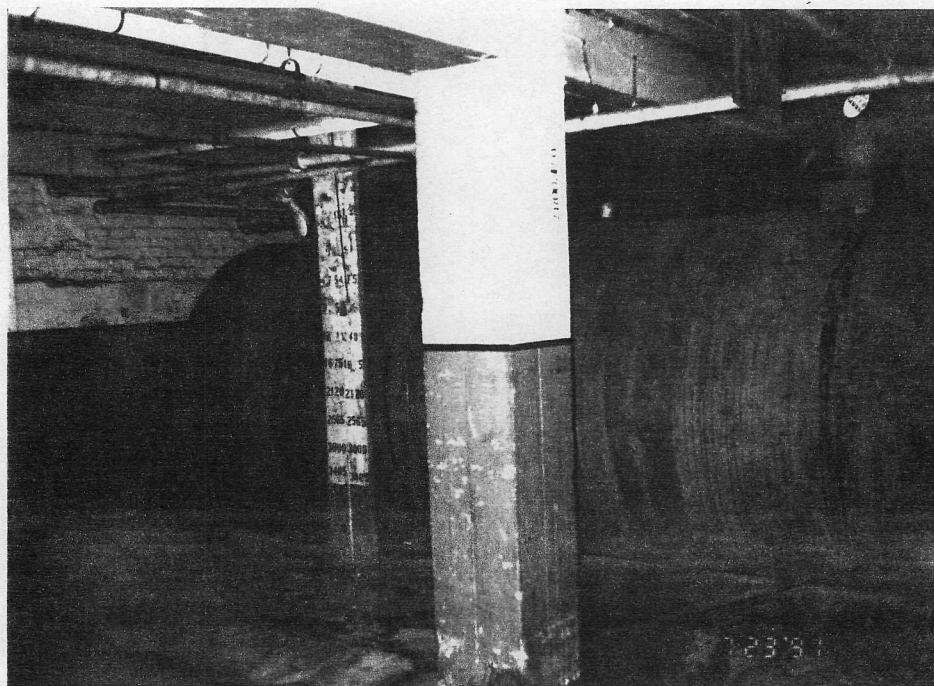
Photograph No. 74

Description: This picture shows one of four 10,000-gallon tanks located in the basement of Building 11. The other tanks are arranged behind the tank pictured here. Note the stains on the ground in front of the tank.

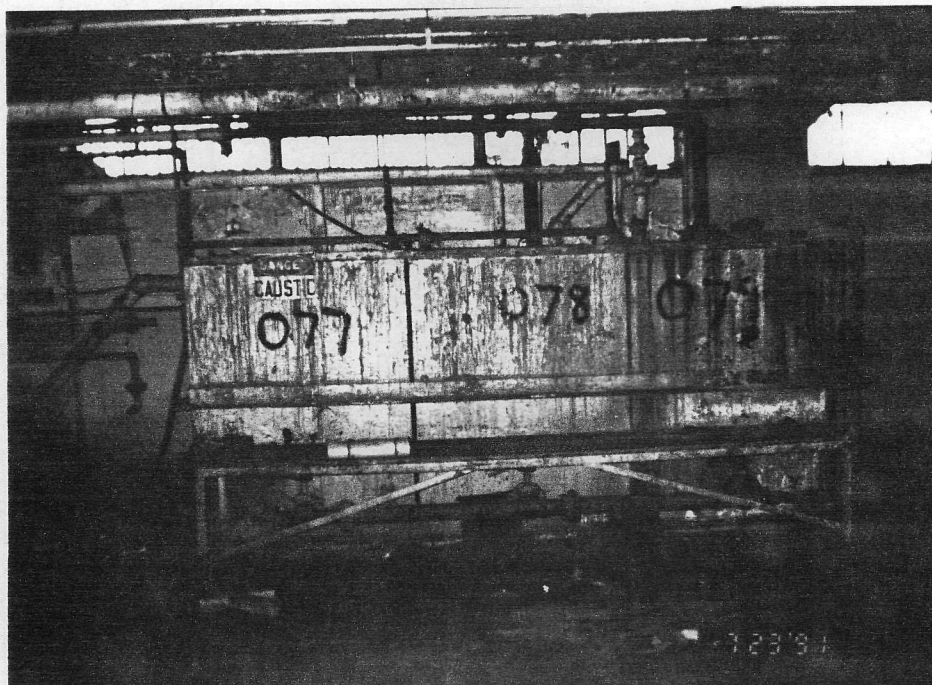
Photograph No. 75

Description: This picture shows Tanks 77, 78, and 79. These tanks are located in the basement of Building 12. The tanks pictured here probably belonged to a caustic cleaning system when the plant was operational. Note the piping insulation located in front of Tank 77. This insulation may contain asbestos.

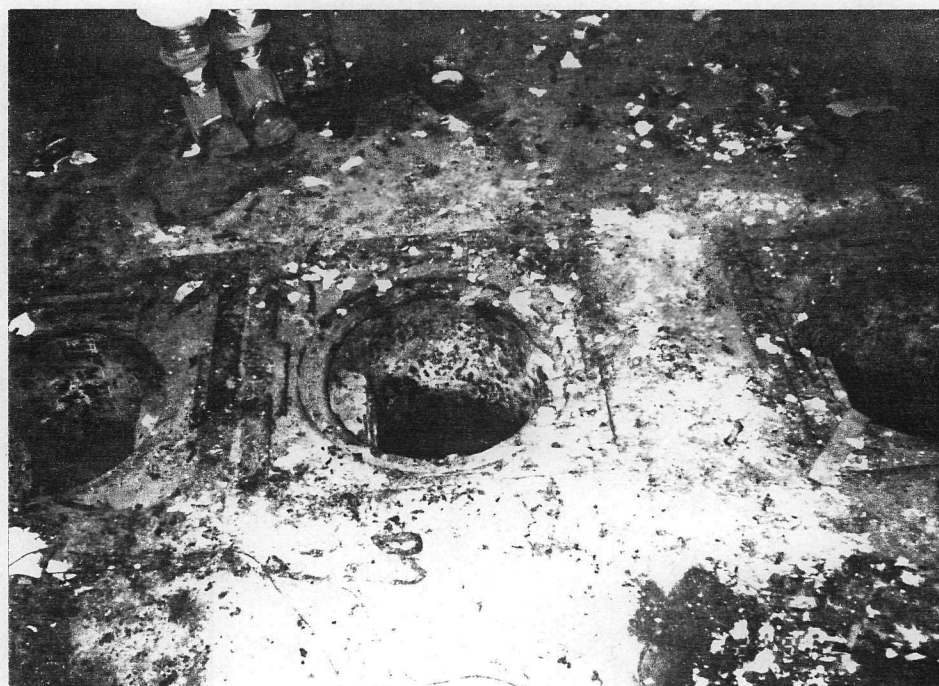
Photograph No. 76

Description: This picture shows three pits located at the west end of the basement of Building 12. The pits are of unknown depth and contained a dark orange liquid. This picture was taken near a room containing spilled oil and several nonoperational transformers; therefore, the liquid may contain PCBs. Note the white debris on the floor.

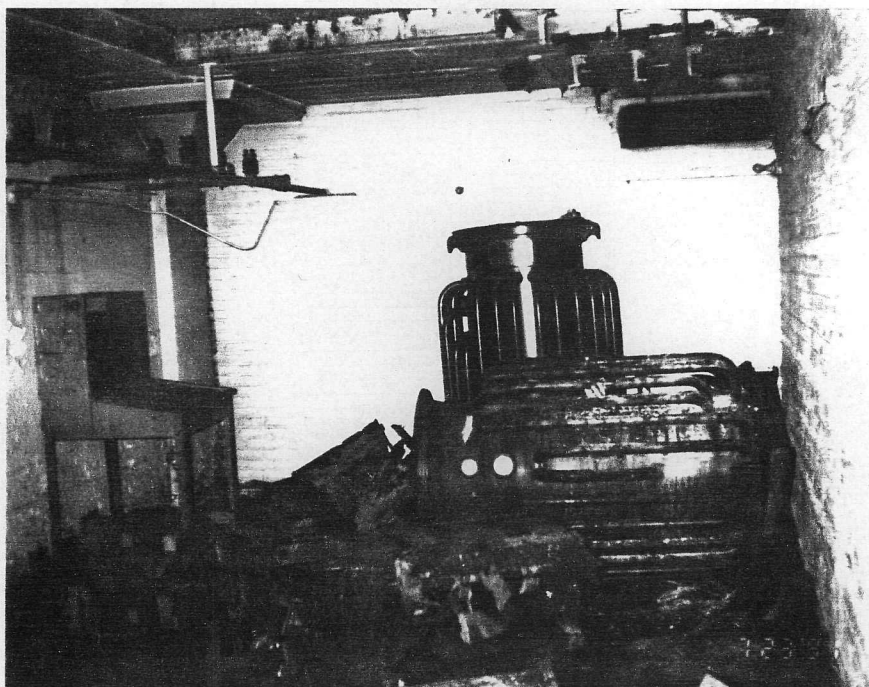
Photograph No. 77

Description: This picture shows two of three nonoperational transformers in a small room at the west end of the basement of Building 12. The floor of this room was pooled with oil (that may contain PCBs) and piping insulation (that may contain asbestos).

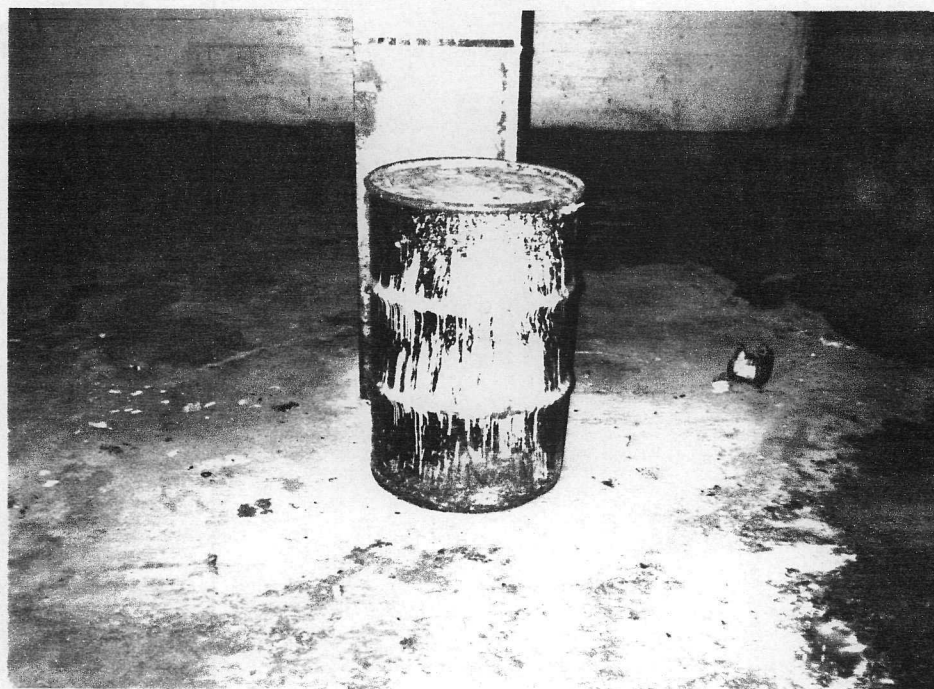
Photograph No. 78

Description: This picture shows a full drum located in the basement of Building 13. The drum was sealed, and no headspace readings were taken with the PID.

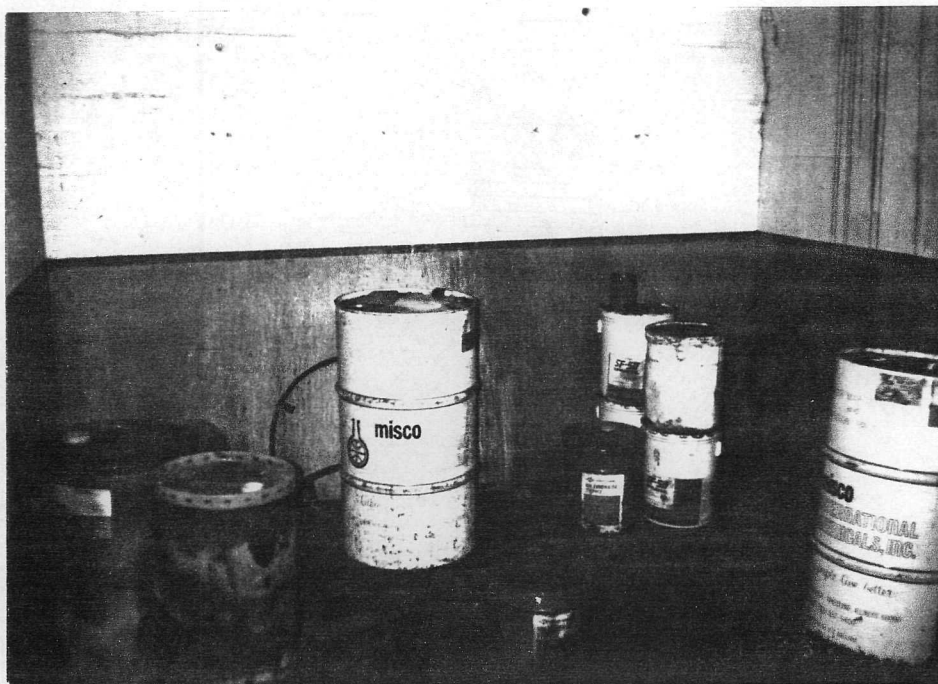
Photograph No. 79

The basement of Building 14-A contained a room filled with liquid to a depth of several inches (see photograph 79). PRC could not determine the source of the liquid. PRC observed 11 drums and other containers in this room. PRC did not cross the room to read the labels on the containers because of safety considerations. The walls in this room were stained with a light-colored, oily substance and a darker, streaked material. PRC determined that this building has a floor space of about 800 square feet (see Table 1).

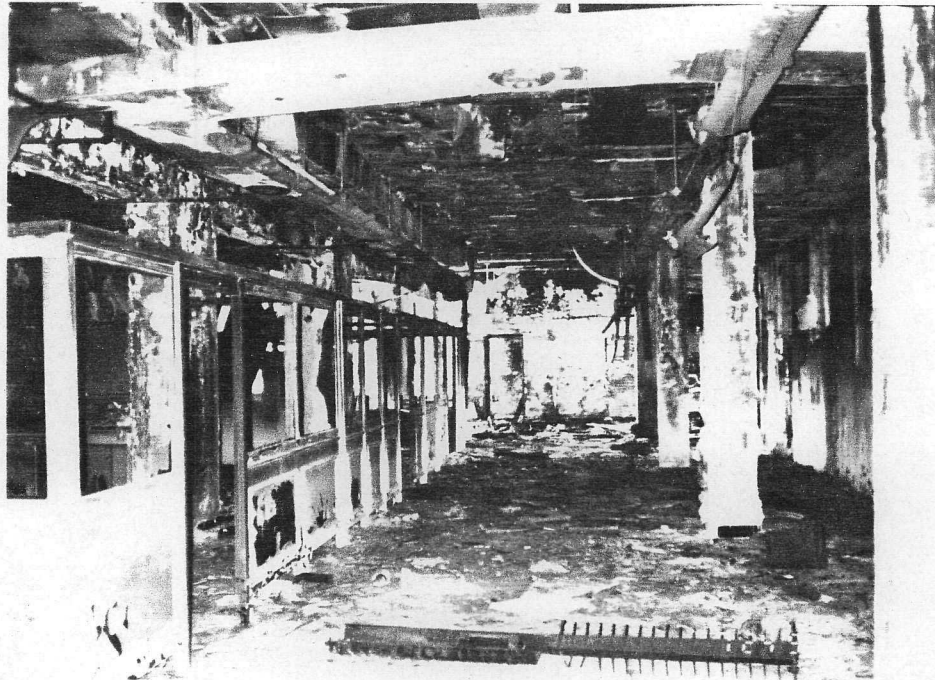
Photograph No. 81

PRC observed extensive fire damage on the first and higher floors of Buildings 13, 14, and 14-A (see photographs 81, 86, 97, and 105). Therefore, PRC did not enter those buildings above the basement level. Valspar stated during the VSI that these buildings were used for office space. Before Valspar used the facility, these buildings were also probably used for office space (Armstrong Paint, date unknown).

PRC observed the second floor of Buildings 13 and 14 through a doorway into Building 14 from Building 12. The buildings were gutted by a fire in August 1990, and PRC did not enter the room because of safety concerns (see photographs 81, 86, 97, and 105).

PRC did not observe Buildings 13-A and 13-B during the VSI, because these buildings were burned in a 1990 fire (see photographs 81, 86, 97, and 105). Both buildings were two-story structures before the fire (Armstrong Paint, date unknown). Fire damage was extensive, and PRC did not enter these buildings for safety reasons. Goodwill and Valspar both indicated during the VSI that this portion of the facility was used as office space. According to the maps obtained after the VSI, these buildings contained storage and office rooms (Armstrong Paint, date unknown). PRC determined that Buildings 13-A and 13-B had a combined floor space of approximately 5,200 square feet (see Table 1).

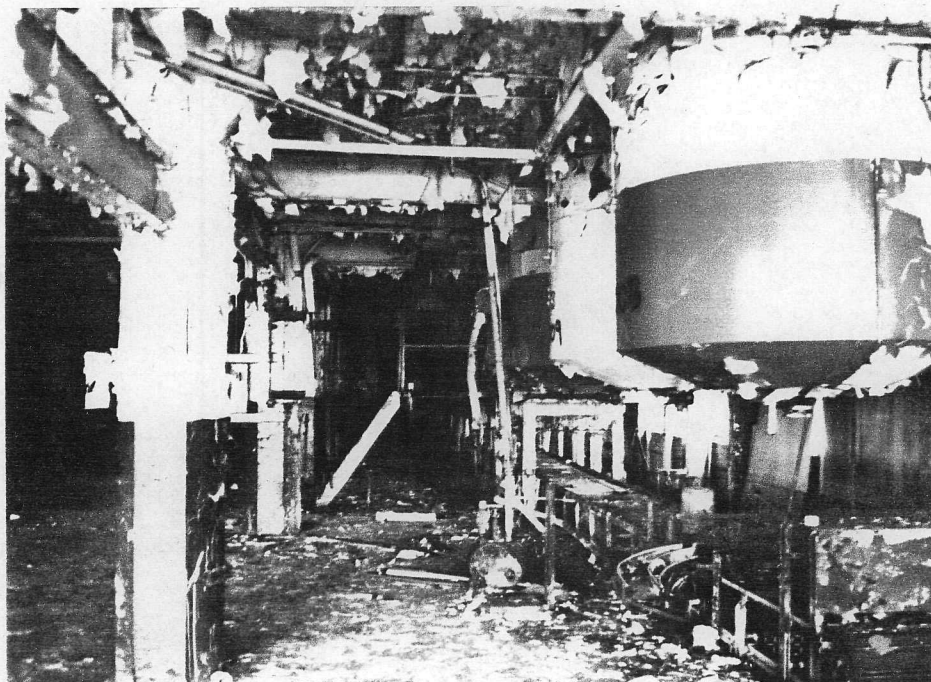
Photograph No. 84

PRC observed a row of 22 multicolored tanks along the north wall of Building 12 (see photographs 83, 84, and 85). The bottom portions of the tanks were painted blue, white, yellow, or green. PRC observed that materials had leaked from at least two of these tanks to the floor. PRC observed another tank located near a doorway through the west wall in the southwest corner of the room. PRC also observed one 30-gallon, rusty drum. Information provided to PRC after the VSI indicates that Valspar used 24 tanks on the third floor of Building 12. Twenty-three of

Description: This picture shows a row of tanks along the north wall of the third floor in Building 12. The tanks are numbered from east to west, beginning with Tank 8 and ending with Tank 28. Note the peeling paint and the small, wet areas in front of the tanks. By knocking on the tanks, PRC determined that some of these tanks may be partially full. Other tanks were obviously empty. Some of these tanks were leaking from their fill pipes.

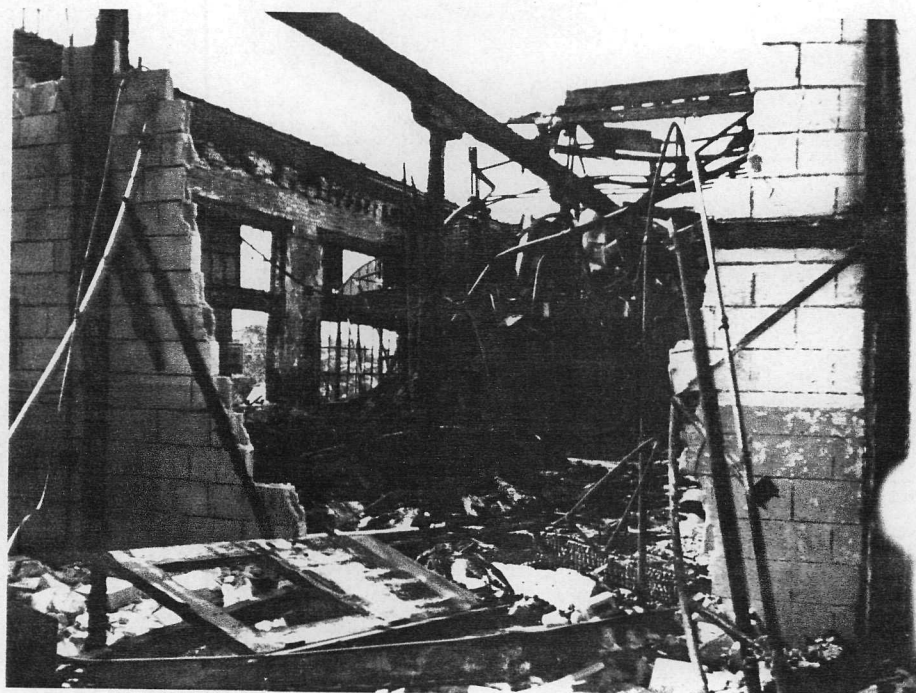
Photograph No. 86

Description: This picture was taken from the third floor of Building 12. It shows the burned portion of the third floor of Buildings 13 and 13-A. PRC did not investigate this floor of the building because of safety concerns.

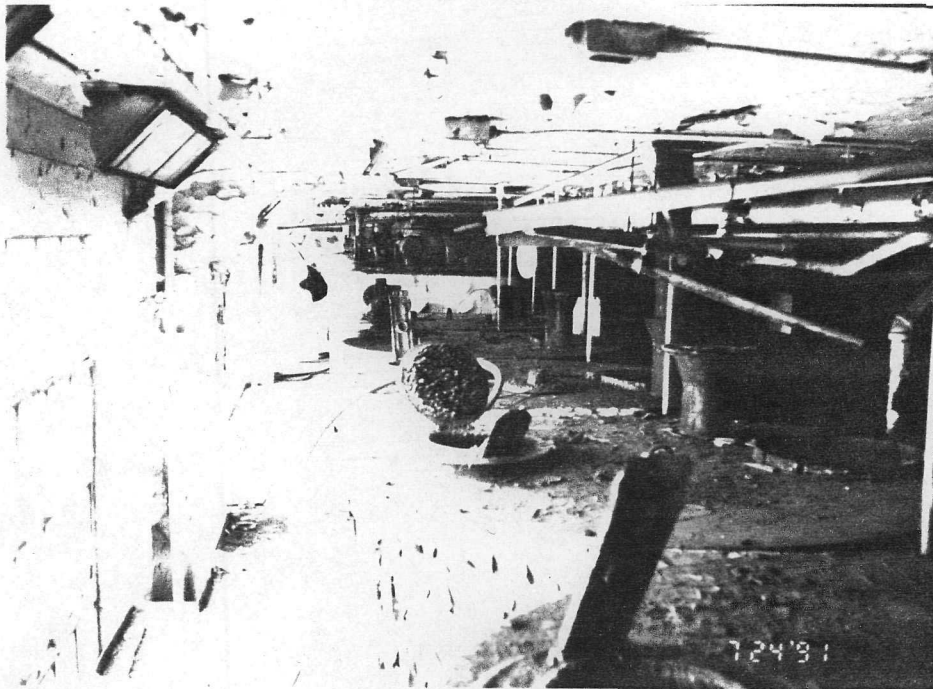
Photograph No. 87

PRC observed 20 tanks on the third floor of Building 7 (see photograph 87). These tanks were aligned in rows along the south, west, and north walls of the building. They had been painted various colors, and most of the paint on the tanks was peeling off at the time of the VSI. The tops of many of the tanks were open, and PRC observed paint residues in almost all of the 20 tanks. The paint residues were coated on the bottom, walls, and top of each tank. PRC could not determine the thickness of the paint residues. Three tanks that did not contain paint residues had been cut open and apparently cleaned. Information provided to PRC after the VSI indicates that Valspar used 20 tanks and one small glue pot on the third floor of Building 7. The tanks have volumes ranging between 450 and 1,600 gallons (IT, 1990b). The paint on the ceiling and walls of the room was chipping off. The floor was covered with debris, including dust, paint chips, spilled paint, and glass.

Description: This picture shows a number of tanks on the third floor of Building 7. This room contains tanks numbered from 30 to 49. Three tanks have been cut open and emptied (Tanks 41, 42, and 48). A number of these tanks contain a thick paint residue. Many of the paint tank lids have small, solidified paint stalactites hanging from them (center of picture).

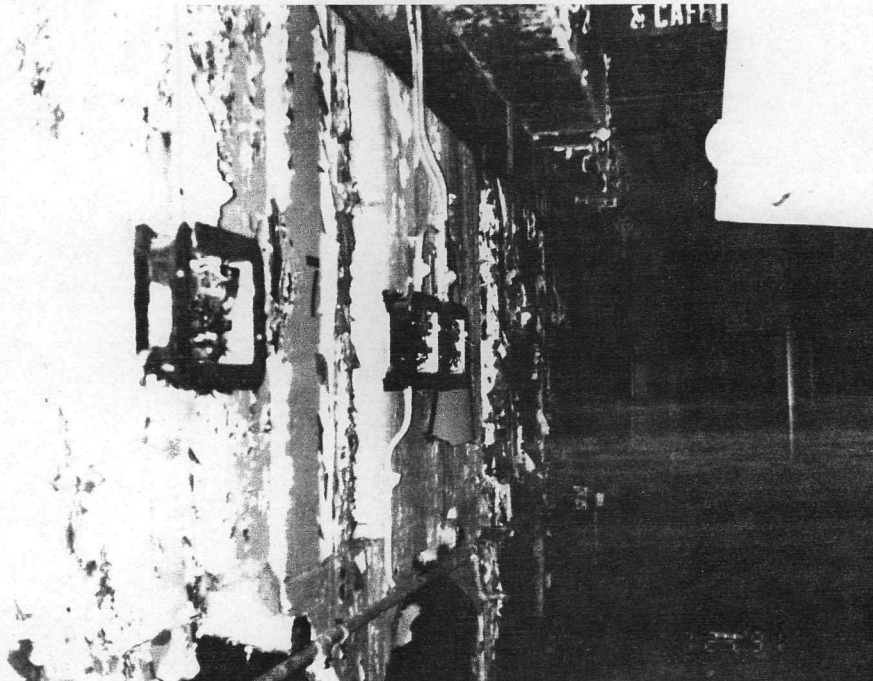
Photograph No. 88

PRC observed 18 tanks on the third floor of Building 8 (see photographs 88, 89, and 90). All but one of the tanks were aligned against the south and west walls. The other tank was located in the center of the building. PRC noted that at least six of the tanks in this room had been cut open and drained. Information provided to PRC after the VSI indicates that Valspar used 18 tanks on the third floor of Building 8. The tanks have volumes ranging between 550 and 1,600 gallons (IT, 1990b). The paint on the ceiling and the tanks was chipping off, and the paint chips were contributing to the debris on the floor. Other debris included dust and glass. The walls of the room contained graffiti. According to Goodwill, a mattress was once located in the northern section of the building, but PRC did not see the mattress.

Description: This picture shows a number of the tanks along the south wall of the third floor in Building 8. These tanks are numbered from 50 to 62. Piping insulation observed in this room may contain asbestos.

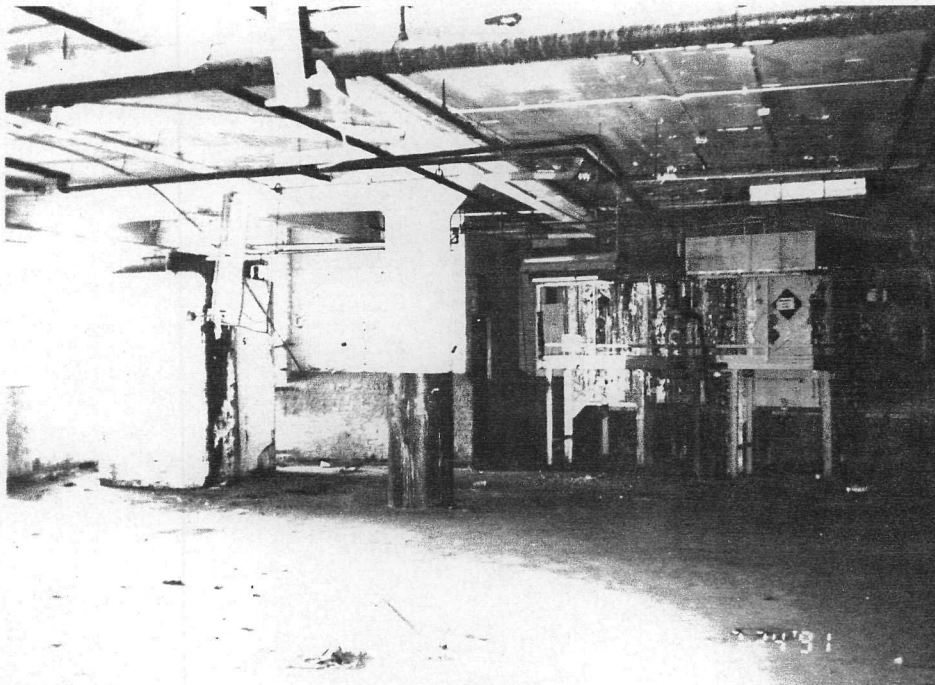
Photograph No. 89

Description: This picture shows tanks numbered from 63 to 67. These tanks are located on the third floor of Building 8 along the west wall. Note the piping along the ceiling of this room. The piping insulation may contain asbestos.

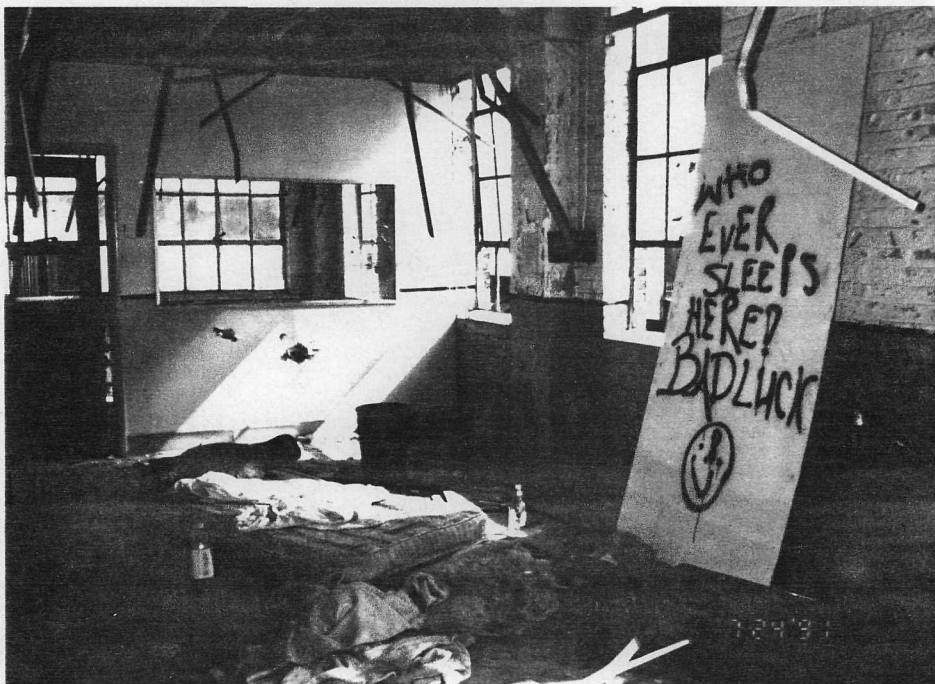
Photograph No. 90

Description: This picture shows a small room in the northeast corner of the third floor in Building 8. PRC believes that this area contained office space. Note the graffiti, the mattress, and the two beverage containers. Based on this evidence, PRC believes that someone uses this room as a living space. Another mattress and some clothing were observed in a small room behind the photographer.

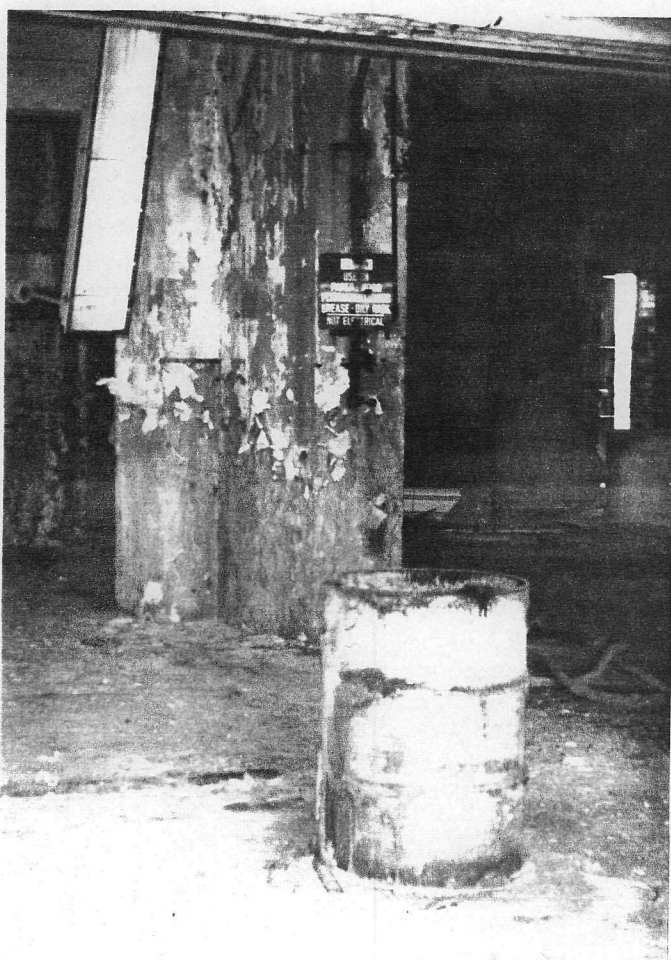
Photograph No. 94

The fifth floor of Building 12 contained one open drum of a yellow, resinous material (see photographs 94, 95, 96, 98, and 99). It appeared that the contents of the drum had leaked to the floor below it. PRC also observed an overturned bucket of orange, resinous material that appeared to have spilled from the bucket to the floor. The floor was covered with dust and debris, and many of the building's lighting fixtures had fallen partially or completely from the ceiling. PRC observed three tanks on the fifth floor of Building 12, and information provided to PRC after the VSI also indicates that Valspar used three tanks on the fifth floor of Building 12. The tanks each have a volume of 500 gallons (IT, 1990b). PRC also observed a thick, orange, resinous material leaking from a pipe near the south wall. The material leaking from the pipe had formed a puddle on the floor beneath its opening. PRC observed a blue tank about 15 feet long, 5 feet high, and 3 feet wide that was labeled "Dust Suppressor" located near the leaking pipe against the south wall of the building. A stairway leading down into Building 14 from Building 12 was also observed. The stairway was not completely intact because of the fire that destroyed Building 14 in 1990.

This picture shows a partially full drum of a yellow substance that appeared to be resin. This picture was taken on the fifth floor of Building 12. Note that the yellow substance has oozed from the top of the open drum onto the floor. Also note the dust on the floor and the peeling paint on the walls.

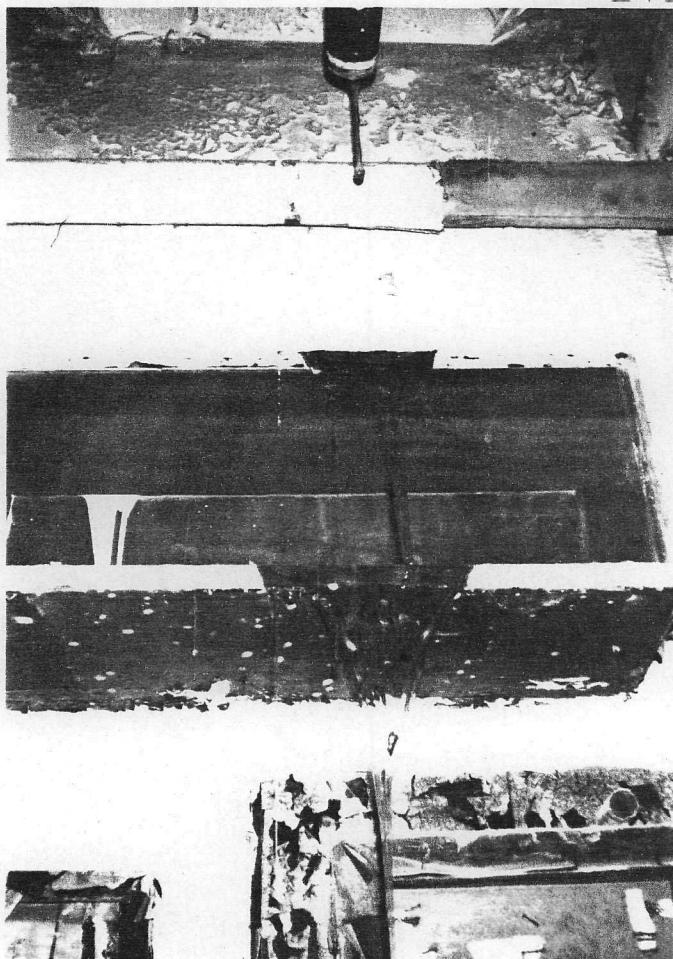
Photograph No. 98
Location: Building 12
Orientation: South
Date: 07/24/91
Description:

This picture shows a pipe dripping an orange-colored, resinous substance. The picture was taken on the fifth floor of Building 12. Note how viscous the substance is. Also note the piping insulation in the upper part of the picture. It may contain asbestos.

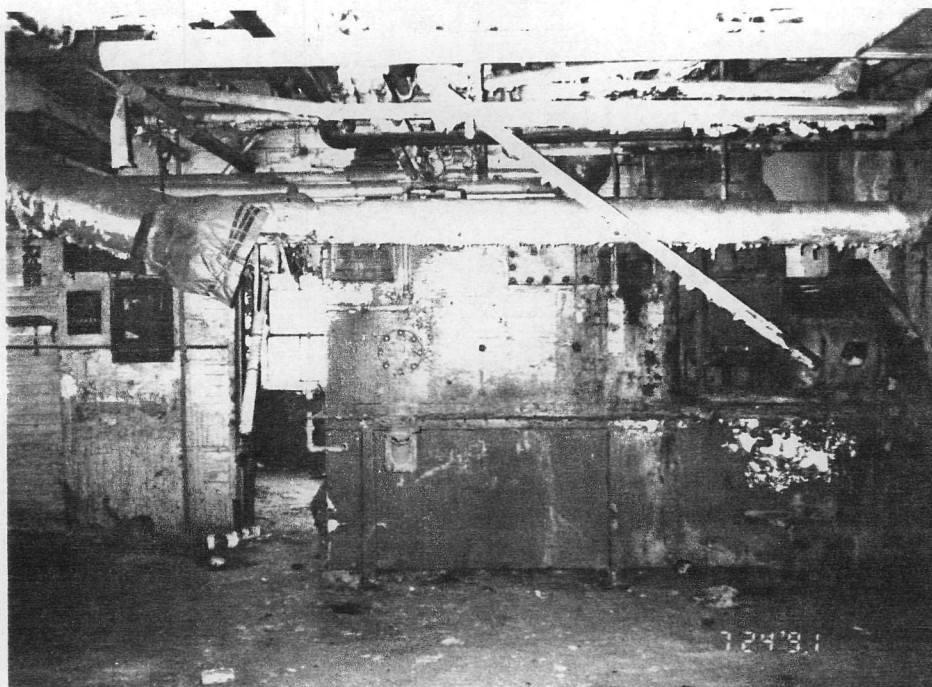
Photograph No. 99

Description: This picture shows a dust suppressor located on the fifth floor of Building 12. The area shown in Photograph No. 98 is located to the left of the dust suppressor and can be seen in this photograph as well. Note the insulation on the pipes running along the ceiling. It may contain asbestos. Piping insulation was also seen on the floor. In the background is a small room that was probably used for storage. Small warning labels containing the words "Caution - Contains Lead" were observed in this room.
